SMART EPC: Record of Inspection & Site Notes

836082

03 October 2013

44 Knapton Avenue
BILLINGHAM
TS22 5DJ

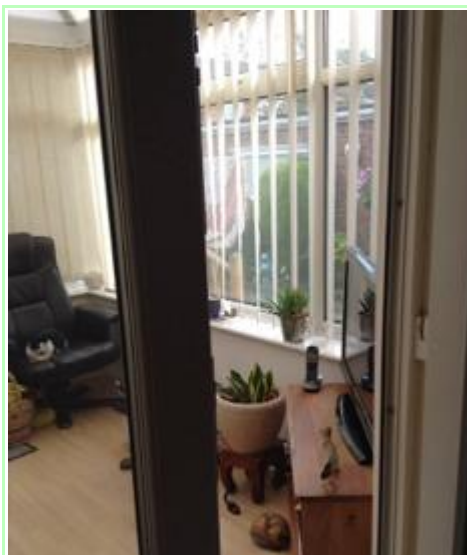
Separated, no fixed heaters

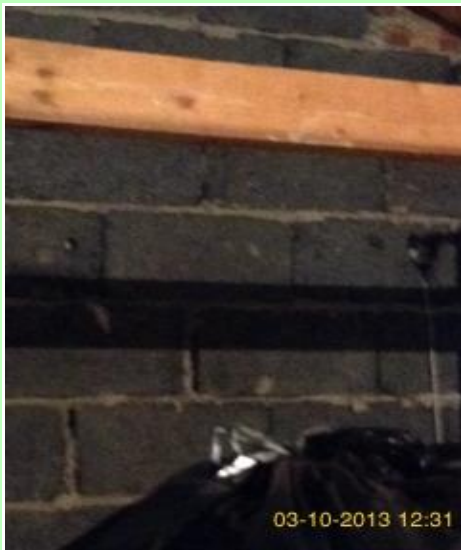
evidence of cavity fill drill holes

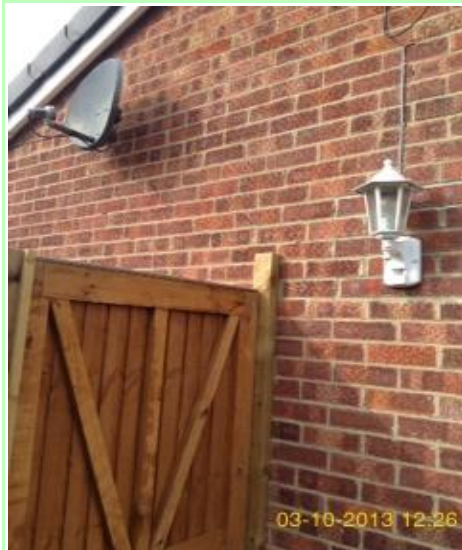
stretcher bond

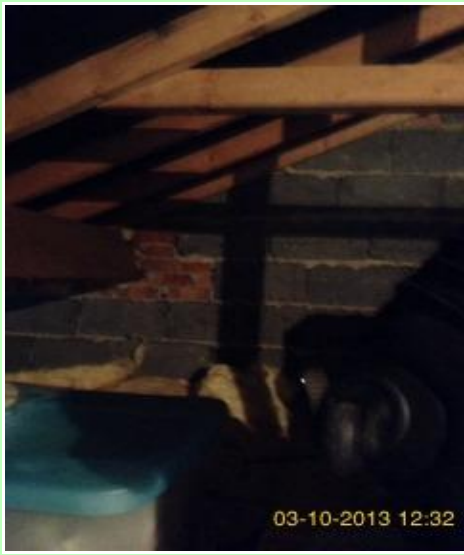
cavity block construction to gable ends

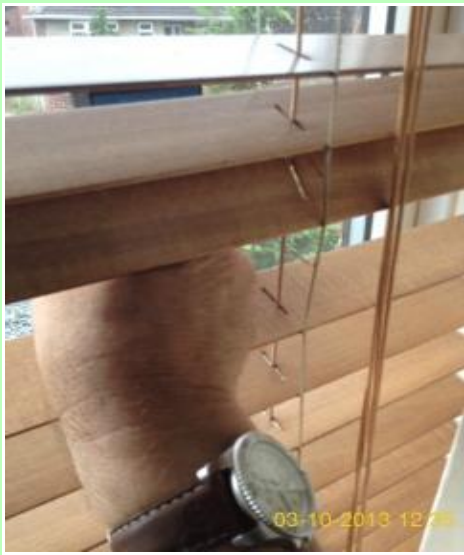
Low "E" Glass detector in use

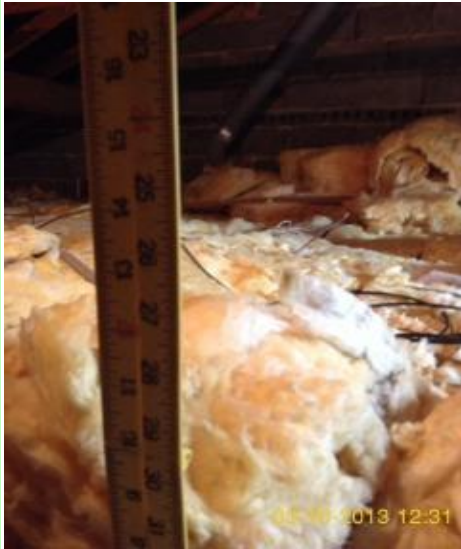
Joists

Construction: **Pitched, loft access**
Insulation: **Joists**
Thickness: **250mm**
U-Value: **Unknown**

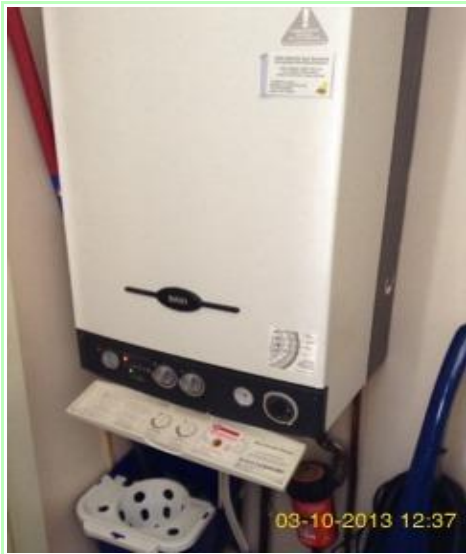
Boiler

System Type: **1998 or later - Combi, auto ignition**
Manufacturer: **Baxi SpA**
Model: **Combi - 105 e**
Seasonal Eff: **78.5**

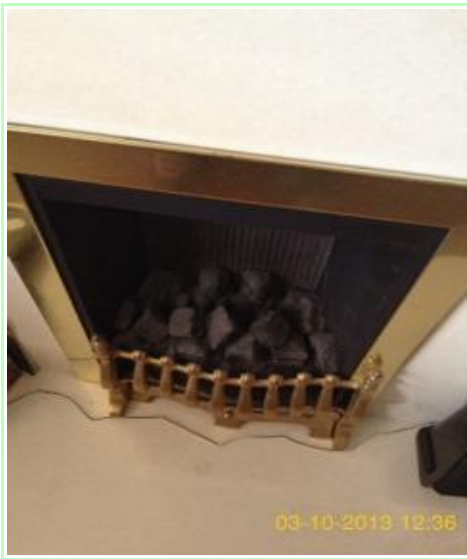
Flush fitting live fuel effect open front fire, sealed to fireplace

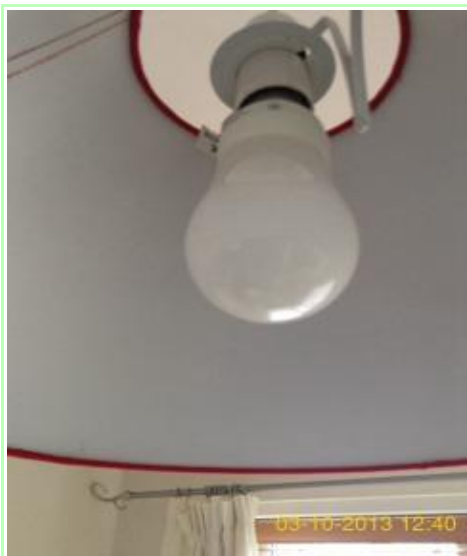
LEL

Water Heating Type	Regular
Water Heating From	From main heating 1
Water heating storage	No Cylinder
Water heating controls	N/A
Solar Photovoltaic	None
Solar Hot Water	None
Total light fittings	8
Low energy lights	6
